1. Report No. FHWA-SC-09-01		2. Government Accession No.		3. Recipient's Catalog No.	
4. Title and Subtitle Support for the Elimination of Roadside Hazards: Evaluating Roadside Collision Data and Clear Zone Requirements				5. Report Date September 2009

SUPPORT FOR THE ELIMINATION OF ROADSIDE HAZARDS

*EVALUATING ROADSIDE COLLISION DATA
AND CLEAR ZONE REQUIREMENTS*

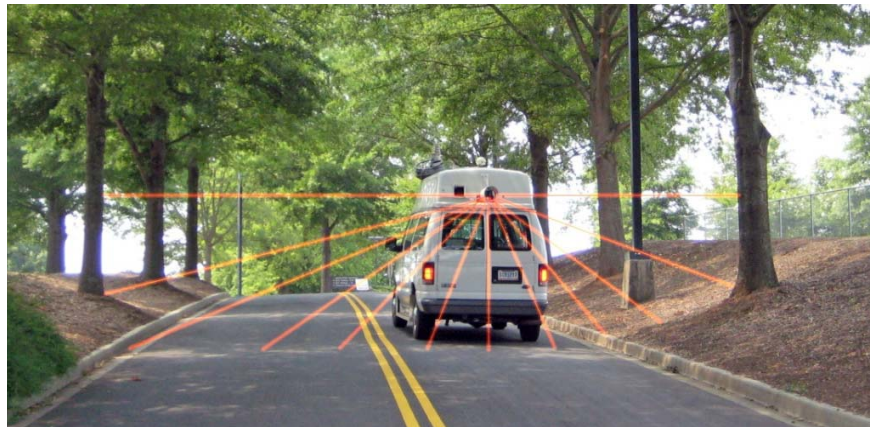
After using a combination of crash data, SCDOT roadway inventory data, and geographic information system analysis tools to identify 287 sites of interest in 14 counties across the state, Clemson researchers surveyed the sites with an instrumented van to identify exact parameters for roadside slopes and distances to obstacles in the clear zones. The van combines video-log capability with precision GPS location and a 360° rotating laser measurement device. The laser measures accurately within a few inches up to 50', and allows the determination of precise distances from the edge of the travel lane (pavement marking) to the nearest roadside obstacle (tree, pole, etc.) while also providing roadway cross-slope and roadside slope measurements.

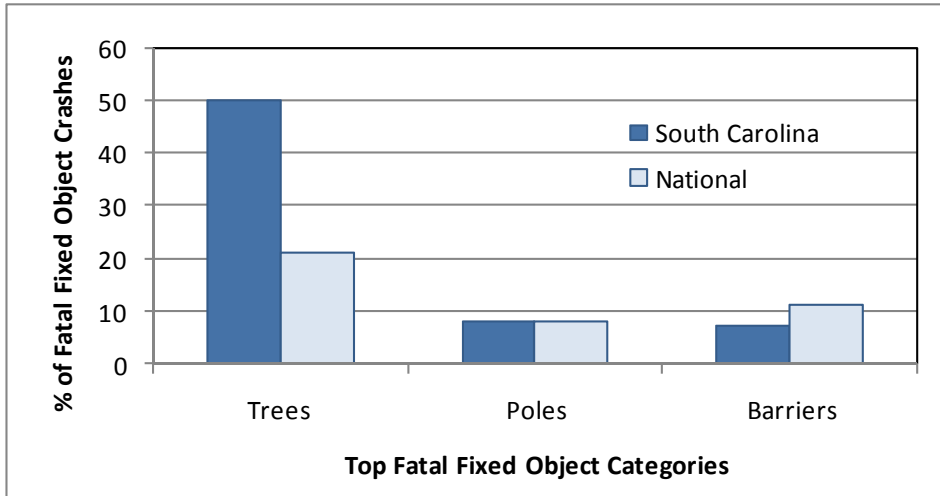
Figure 1 Primary contributing factors in fixed object crashes

In addition to trees, other roadside hazards also impact the safety of South Carolina roads. Figure 1 shows the top three categories of primary contributing factors in fatal fixed object crashes for both the U.S. and South Carolina. The most striking difference between the two was the involvement of trees – 21% nationally, yet 50% in South Carolina.

Utility poles and guardrail barriers are also noted in Figure 1 as contributors to fatal fixed object crashes in South Carolina. The use of guardrail to shield motorists from fixed objects is an option to mitigate crash severity. It is important to realize that the placement of guardrail in itself may serve as a roadside hazard that can result in serious injury or fatality should it be struck by a vehicle.

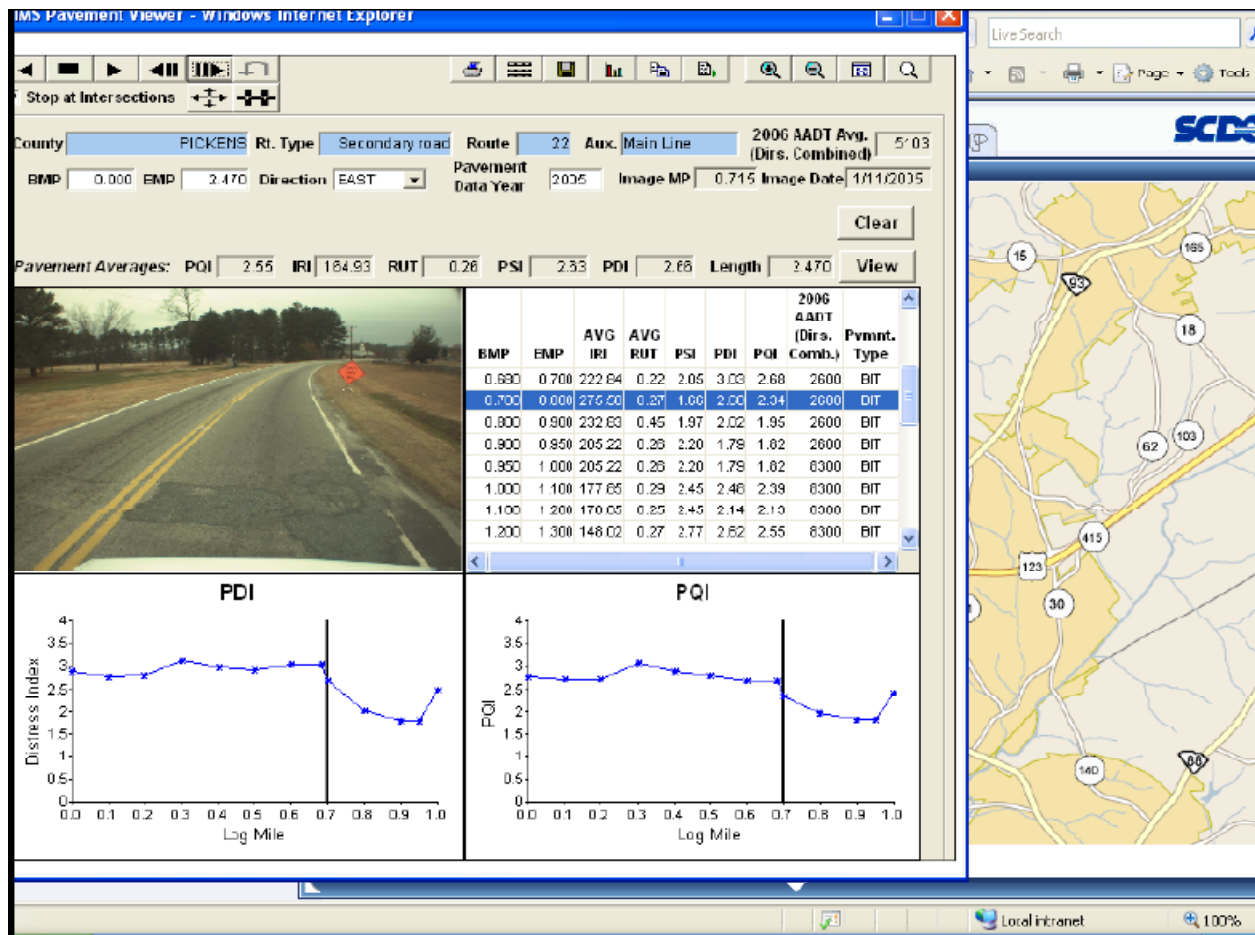
Figure 6 Screen-shot of RIMS Pavement Viewer showing several data fields of interest

In addition to the SCDOT crash databases, a need existed for information about the crash site locations that could not be obtained from the police reported data. Elements such as the number of lanes, functional class, traffic level, and posted speed limit were necessary to stratify the sample and determine the required clear zone. SCDOT allowed the research team access to the inventory portion of the enterprise data system at the Greenville District office. Researchers were able to manually extract data for crash sites of interest and verify that no work had been done in the area as of the time of the photo-log contained in the system (see Figure 5). The photo log also helped to provide information on missing or questionable data. Unfortunately, the RIMS search required route and milepoint information for quick searching and the base map that was used for locating the crashes to roadways did not have that level of information. However, the pan and zoom options were used to identify the locations. The RIMS database was a useful tool for the initial sample selection and site verification. Figure 6 contains a screen capture from the Pavement Viewer showing the photo-log, county, route type, route number, 2006 AADT and other location information.

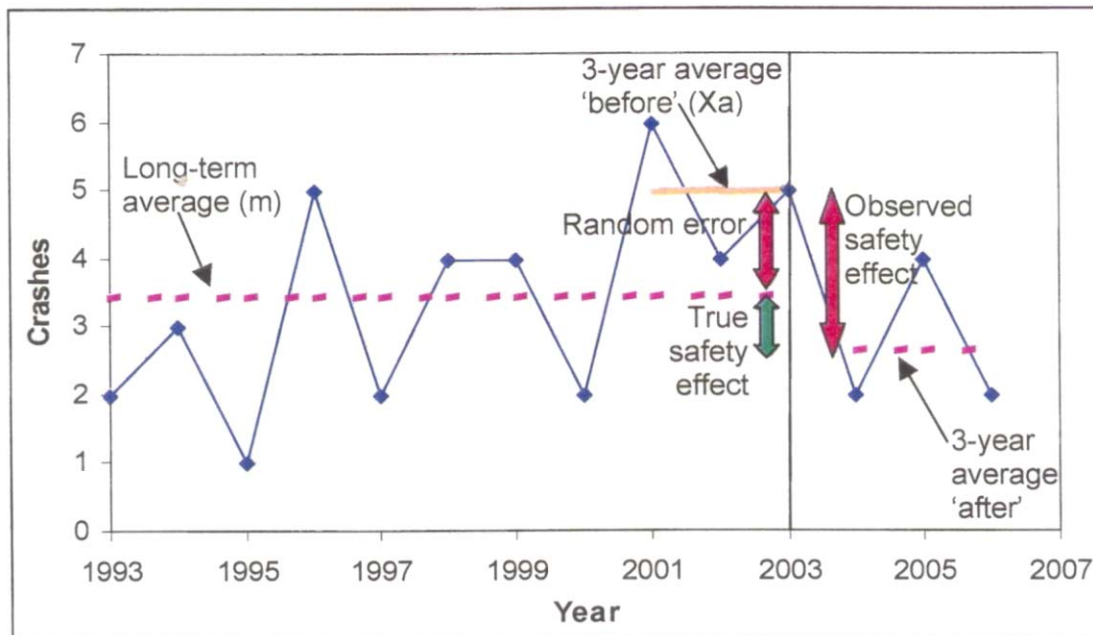
Figure 7 Regression -to-the-mean Effect

Historically, researchers have defined high-hazard sites based on high frequency or high rates of crashes over relatively short periods of time (3-5 years). The highway safety literature is filled with examples of studies where locations with the highest crash counts/rates were purposely selected for countermeasure implementation. Nearly all of these studies have shown very impressive safety improvements (10%-50% reduction in crashes are typical), regardless of the type of countermeasure. The phenomenon of repeated measures of data in the long-run drifting towards a mean value is known as “regression-to-the-mean”. Regression can occur up or down (see Figure 7).

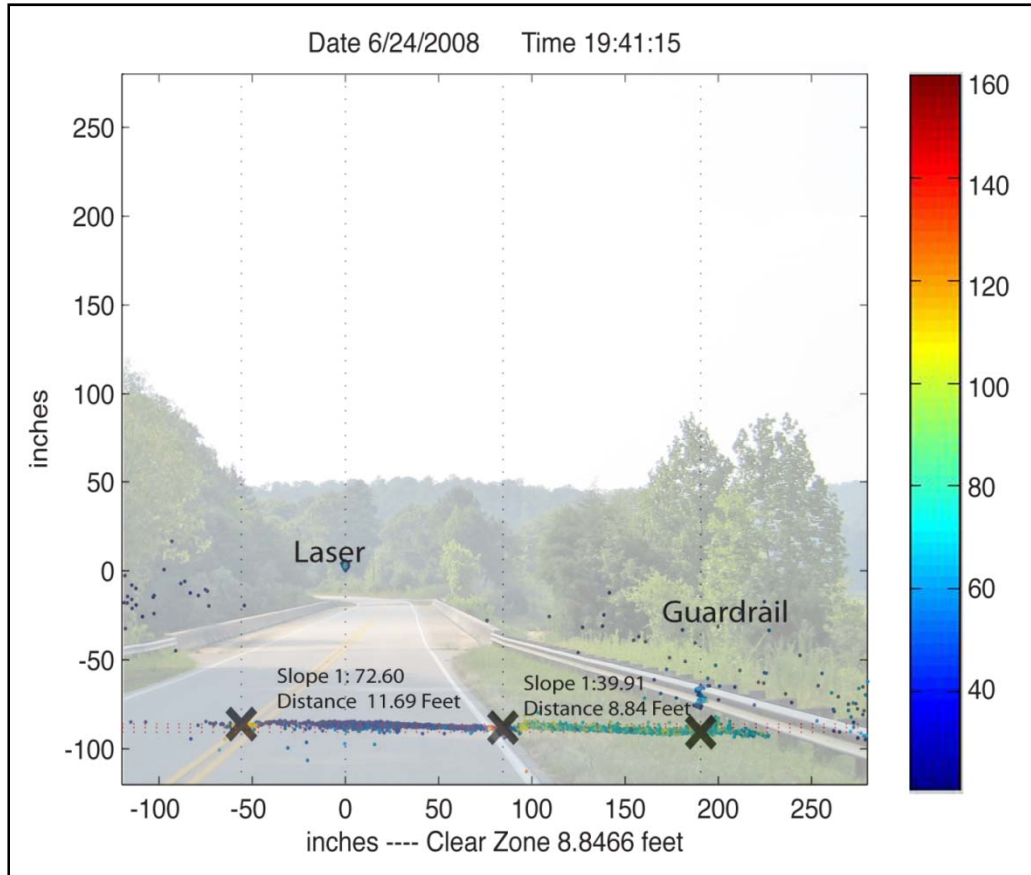
Figure 16 Overlay of point output from laser measurement device with video-log photo

Figure 16 shows the laser data obtained for a roadway section with a guardrail. This data has been overlaid on a video-log photo of the site to show how the readings identify different surfaces. The original measurements are in inches from the laser. The bar on the right side of graphic indicates the amplitude level. The measurements make it possible to calculate straight line distances from the pavement markings noted with X's to the guardrail. At this site, the guardrail is 8.84 feet from the

pavement edge of pavement. The distance of 8.84 feet is the horizontal component distance, not the distance along the sideslope.

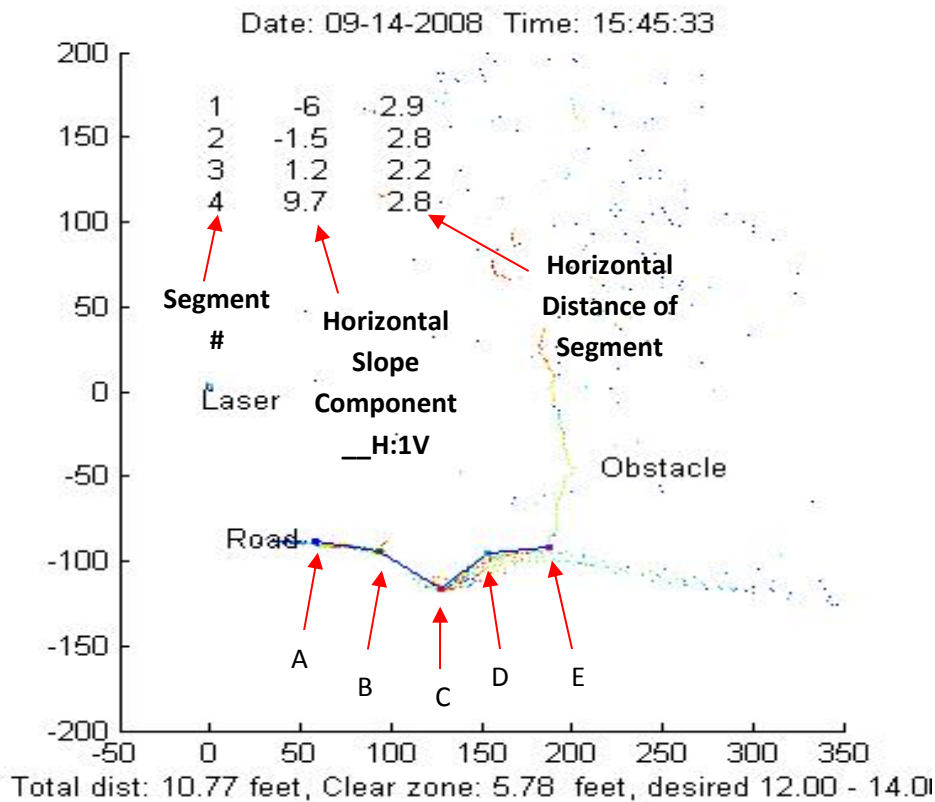
Figure 17 Roadside Slope Segmentation

Finally, the software allows the user to select multiple linear segments (see Figure 17) to correspond with changes in the roadside terrain. By clicking at various points where major changes in the side slope occur, the software calculates horizontal distances for each segment and provides the slope of the individual segments. For this particular measurement, there are 4 slope segments. Starting at the edge of the travel lane, the segments are numbered from left to right. The graphic provides measurements in inches, although the program calculates segment lengths in feet. The segment between A and B is segment 1. Segment 1 has a slope of 6H:1V with a horizontal distance of 2.9 feet. Segment 2 is between B and C, and so on. The three columns in the top left corner of Figure 17 represent the segment number, horizontal slope component of the sideslope in __H:1V, and horizontal distance of the

segment. The program also automatically checks for traversable and recoverable slope status and either includes or excludes sections from the total clear zone and clear zone run out area. Below the graphic is information on the total horizontal distance (total dist.) from the edge of the traveled way to the obstacle, the calculated functional clear zone (clear zone) based on slopes for each of the segments, and the desired clear zone (desired) based on the predominant slope, roadside slope configuration, and site characteristics such as speed limit and ADT. If the clear zone value is less than the desired range, then the site is classified as not meeting clear zone requirements.

The measurement samples (dots) indicate the location of the first hard surface edge that is touched by the laser. Thus, trees, poles, and other solid items appear as linear features. Also, note that the figures represent measurements taken over 1 second. There are multiple rotations of the laser during that one second, and at the same time the van is moving down the roadway. So the roadside slope is in a constant state of change, and each second can be slightly different from the next and may even have some variation within the same graphic. The slope measurements are made to coincide with the major point distributions.

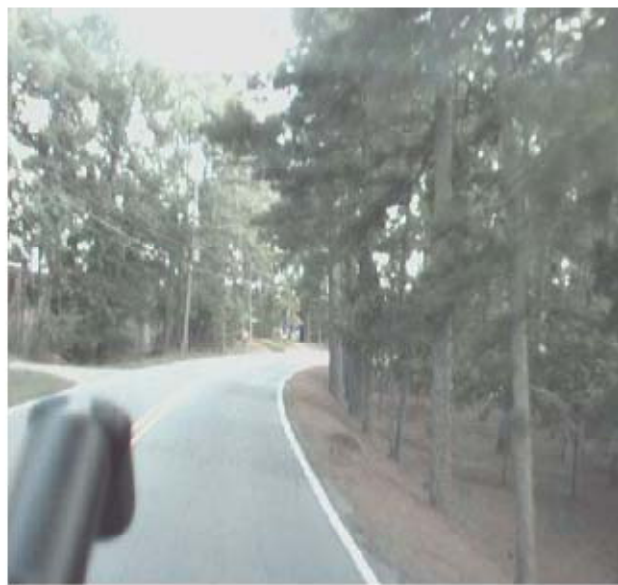
Figure 19 Second Page of Detailed Clear Zone Site Inventory Report

SITE ID:
 NSITE: 174Tree
 LONGITUDE: -81696757
 LATITUDE: 33525333
 PRIMARY NAME: owderHouse RD SE
 SECONDARY NAME: State Highway 440
 ROUTE TYPE: Secondary
 LANE 2
 SPEED LIMIT (mph): 35
 ADT: 4500
 DIRECTION: SE
 HRZL CURVE: Yes

The fill section sideslope for the sample given in Figures 18 and 19 was found in two segments. The first segment was a slope of -25H:1V for a horizontal distance of 2.2 feet, the second segment had a slope of -2.1H:1V for a distance of 6.5 feet. The second segment is steeper than 4H:1V, and therefore is not included in the clear zone because the vehicle cannot redirect nor come to a stop on this slope (see Figure 20). The segment two sideslope is also steeper than 3H:1V, and thus is not traversable either. The resulting available clear zone is limited to the 2.2 feet in segment one. At a slope of -25H:1V, with posted speed of 35 mph and 4500 ADT, a clear zone in the amount of 12-14 feet is required. The available 2.2 feet is significantly less than required. The required clear zone calculation also assumes a straight section of roadway, since this site is on a horizontal curve section, AASHTO recommends increasing the clear zone in proportion to the radius of curvature for the particular posted speed (as shown in Figure 21. The amount of the adjustment ranges from 10% increase to 50% increase.

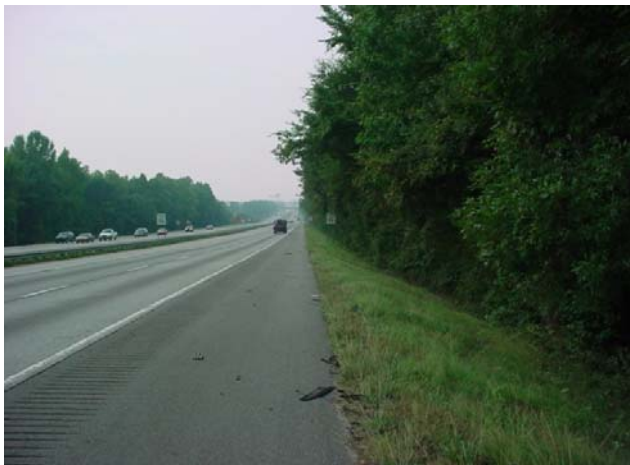
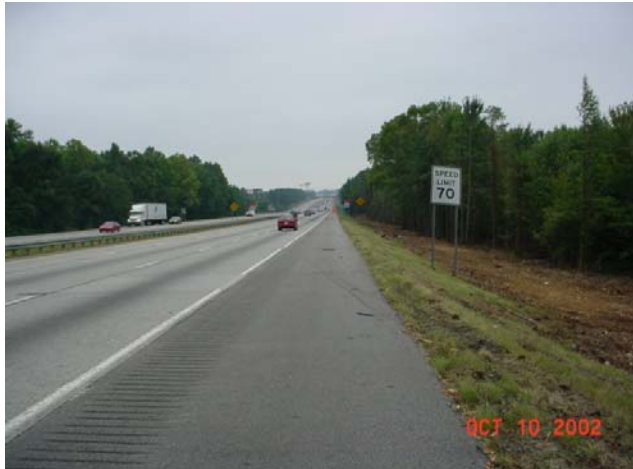
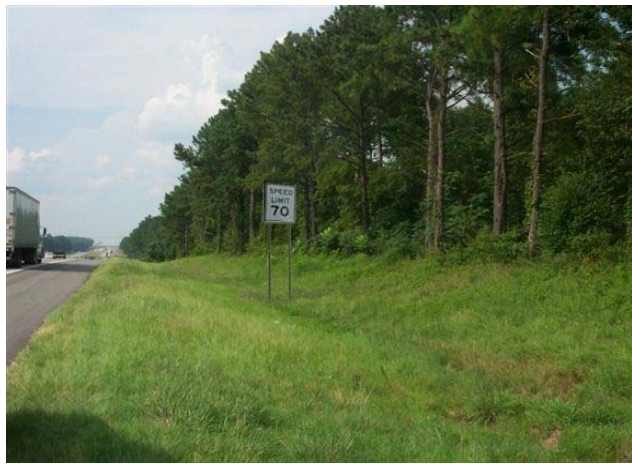
Figure 24 A section of freeway in Georgia (a) Before, (b) During, and (c) After Clear Zone Recovery

Georgia began a rehabilitation and safety program for Interstates and limited access roadways back in 2001. It expands the Georgia Department of Transportation's existing pavement preservation program by incorporating all feasible safety improvements, including pavement rehab; additional and upgrade of guardrails, barrier walls and pavement markings, placement of ground-in rumble strips and maintaining a sufficient recovery area within the right-of-way. The goal of the program is to reduce the number of collisions, injuries and fatalities on the limited-access roadway resulting from vehicles leaving the road by 80 percent. Since fatalities are twice as likely to occur as a result of hitting a tree as any other fixed object, vegetation removal is an important part of the entire safety program. The Georgia Department of Transportation has been clearing vegetation 32' beyond the edge of pavement in urban areas and 50' beyond in rural areas to reclaim the recovery area that once existed along these roadways, but has re-established in the years since the roadways were built. GDOT also has a policy to eliminate or shield all fixed objects in medians of 64' or less. The state has set minimum clear zone distances for various roadway types, ADT levels, and fixed object classification. These values are requirements for all heavy maintenance and reconstruction projects in the state. Figure 26 gives examples of the recovery area before, during, and after clearing activities.
